**Archaeological
Building Survey:**

The Gates, Grotto and
Ice House, Worsley
New Hall. Final
Version.

Client: Peel
Investments (North)
Ltd.

Report No: 14/2012

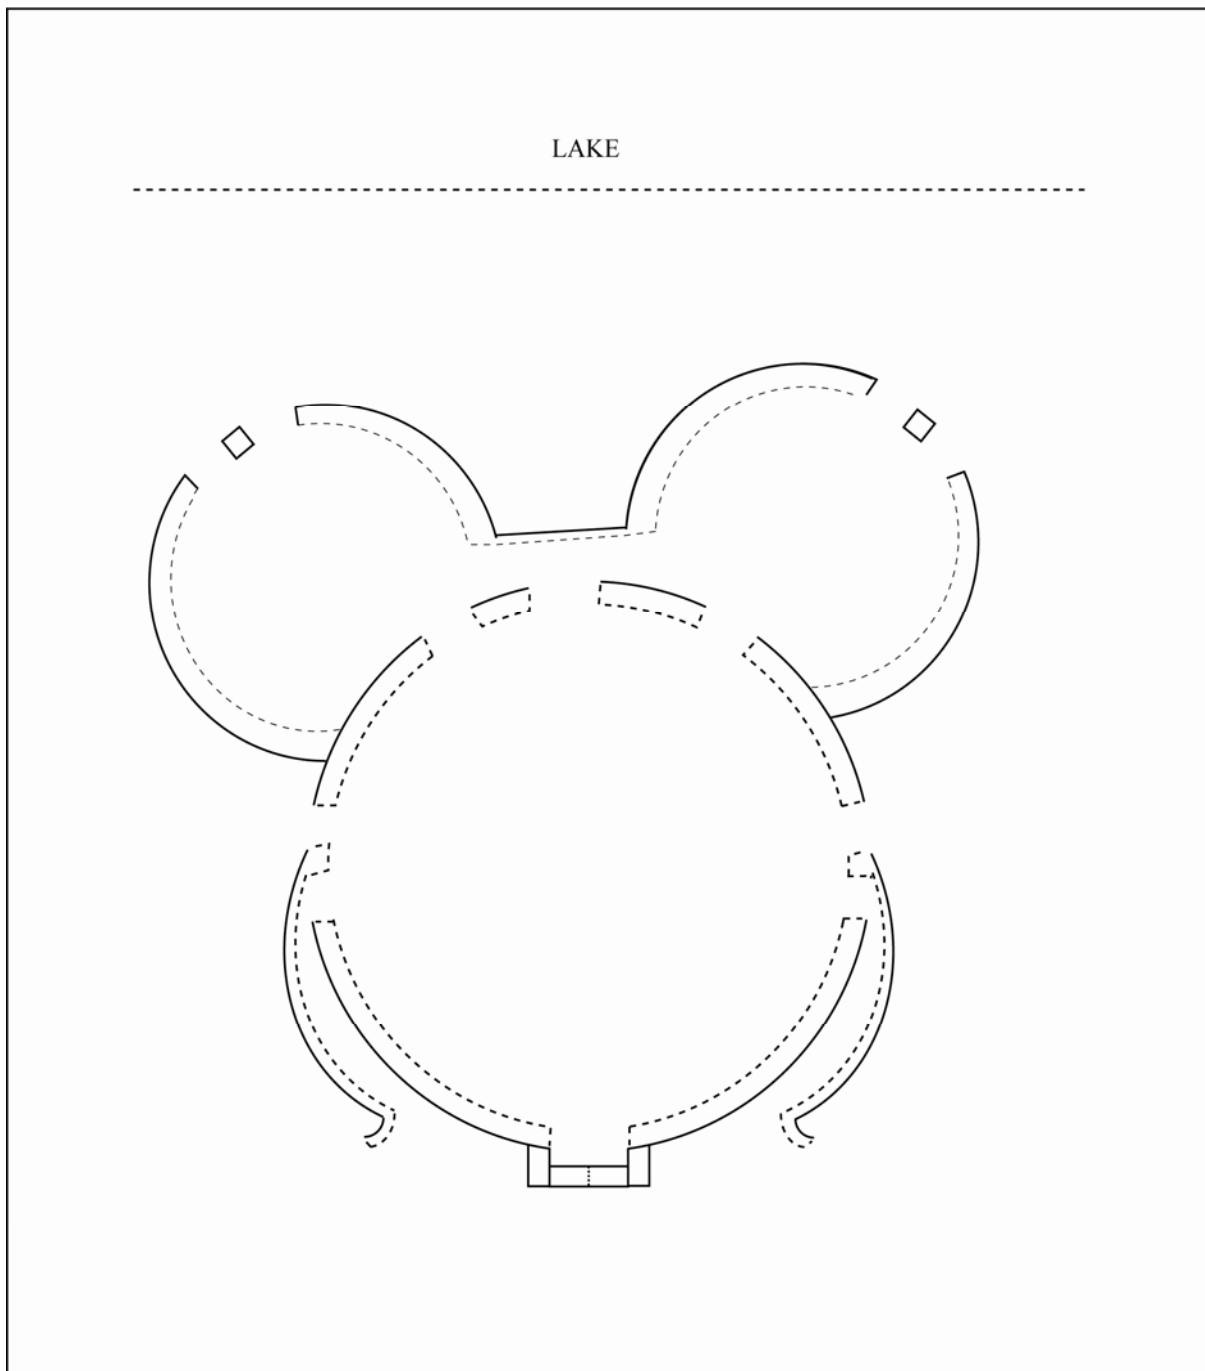
Centre for Applied Archaeology Joule House The Crescent Salford M5 4NW	Title: Folly sketch plan	Key: ----- Assumed wall thickness	N →
	Site Name: Worsley New Hall Site Code: WNH-11 Drawing Ref: BS-WNH-11-4 Date Drawn: 02/02/12 Drawn By: MB

The Grotto consisted of three chambers and two covered walkways. The building was adjacent to the lake and built to the east of the lake. The larger, main chamber was circular in plan and had two smaller, circular chambers built west of it. The smaller chambers protruded from the north-west and south-west part of the main chamber. These were all linked by covered walkways that connected from the north and south centre points from the main chamber into the eastern centre points of the smaller chambers.

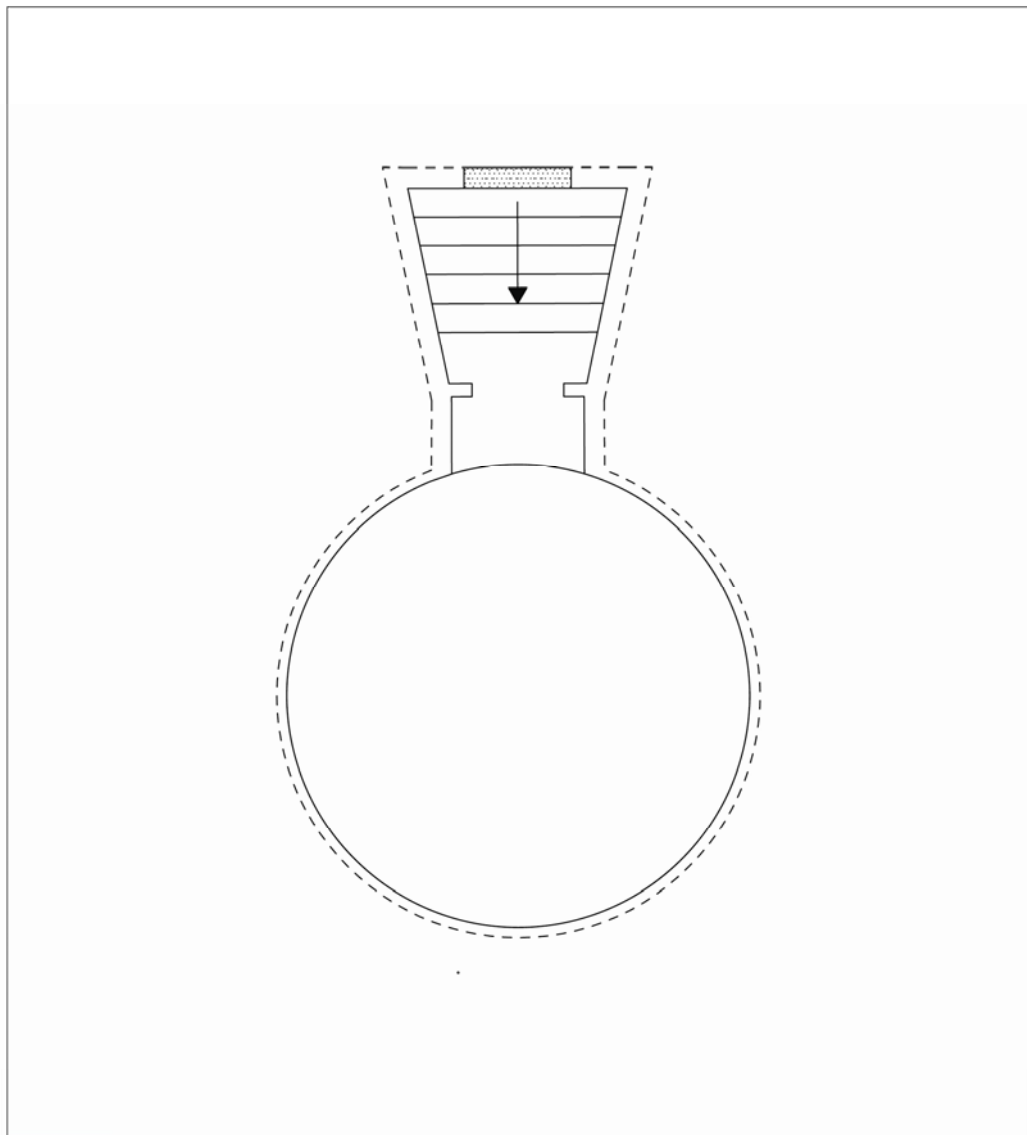
<p>The Centre for Applied Archaeology</p>	<p>Centre for Applied Archaeology Joule House The Crescent Salford M5 4NW</p>	<p>Title: Ice House plan</p>	<p>Key:</p> <p>

Internally a vaulted approach chamber led to the ice chamber. The chamber was 1.85m in height and 1.35m in width. Five brick steps surmounted by stone led down from the external doorway to the vaulted approach chamber. The steps were 0.27m wide and 0.19 deep. The approach chamber had walls constructed of large irregular sandstone blocks laid unevenly. The ceiling was formed by two large ashlar slabs. The approach chamber led to the ice chamber and the doorway separating the two was 0.90m in width and 1.49m in height. The doorway was framed by hammer dressed stone quoins, rounded on the northern side. One iron door hinge pin remained. The doorway had a hammer dressed stone lintel.

The distance from the doorway to the main ice chamber was 0.66m. This led to a drop into the shafted ice chamber that tapered to towards the base. The area immediately behind the doorway, leading to the chamber was barrel vaulted brick. An iron bar fixture remained in the ceiling of this area. The ice chamber was 4.54m in diameter and 4.70m in height. The full height of the chamber was obscured by the base containing rubble. The chamber was barrel vaulted and the brick was laid in an English garden wall bond.

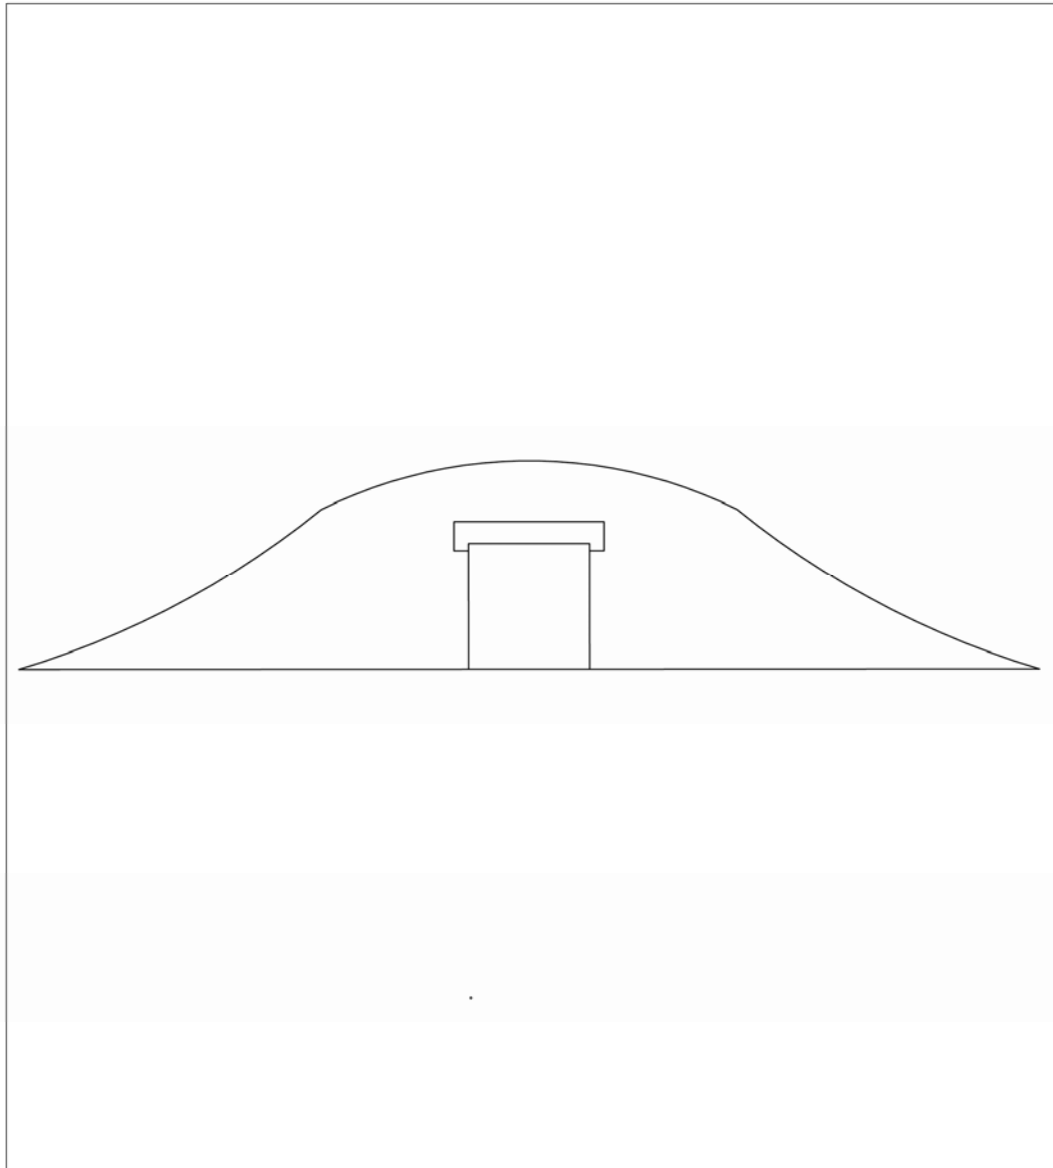
Centre for Applied Archaeology Joule House The Crescent Salford M5 4NW	Title: Ice house northern elevation	Key:

The structure forms a mound in the earth at ground level. It is a brick barrel vaulted structure. The ice house is a ‘Cup and Dome’ style. Its northern elevation was constructed of a segmented section of hammer dressed stonework. It measured 2.15m in length and 1.50m in height, from the ground. The doorway had been blocked with breezeblocks but the ice house was accessible through a small gap. The doorway measured c1.00m wide. Iron door hinges remained in the doorway.

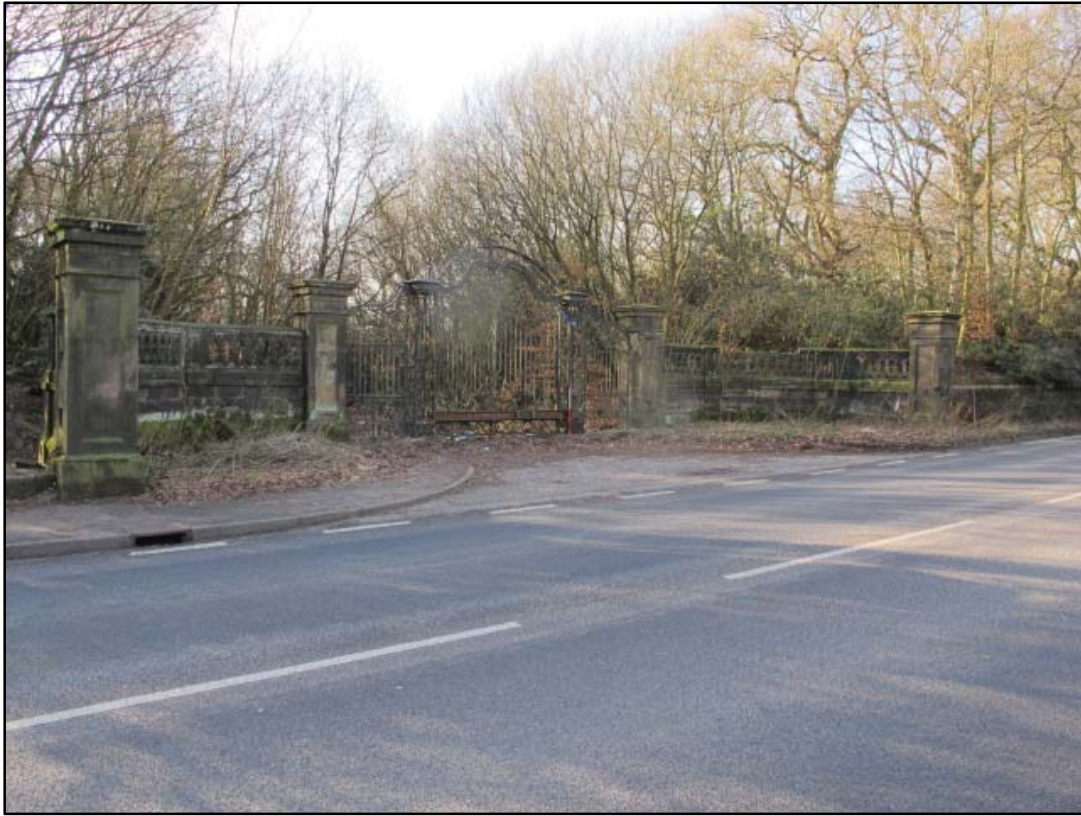
Fig. 8 – Wide shot of gates. Looking South-west.

The gates were constructed of wrought and cast iron. The main gates were double carriage gates. They were supported by intermediate square piers constructed of iron bars. The carriage gates were crowned by the outline of a cartouche. They rose to a Baroque style scrolled head. The double carriage gates had intricate scrollwork at the top and the base. The main gates had smaller pedestrian gates either side. The gates were flanked by bold ashlar pillars. The pillars had moulded stone caps and recessed chamfered panels.

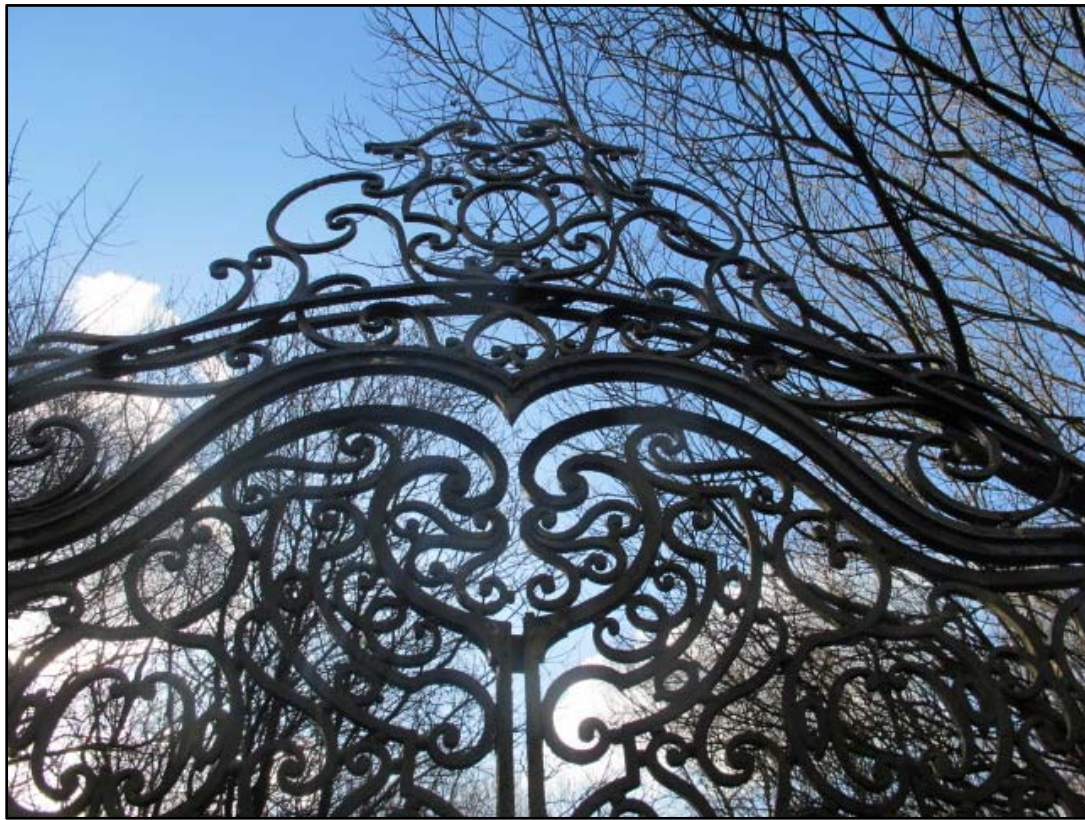
Fig. 9 – Detail of scrollwork above carriage gates. Looking south.

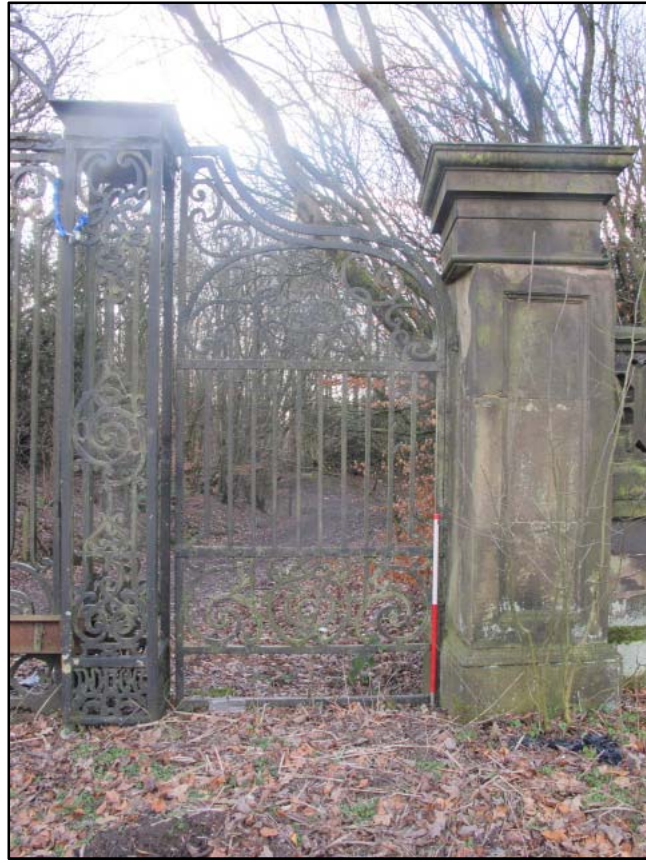
Fig. 10 – Shot of western pedestrian gate and stone pillar. Looking south.

The gates were adjoined by two symmetrical quadrant walls. These walls were constructed of fine ashlar. The walls had stone pillars at each end. One pillar was attached to the gates and one was adjacent to the road. In between the stone pillars were three sections of wall. They angled out from the gates north, towards the road. The wall had an ashlar plinth and the lower part of the wall had four courses. Atop this was a chamfered stone ledge. Surmounting the ledge was a decorative section. This decorative section consisted of adjoining elliptical colonnettes. Atop this sat a moulded stone balustrade. Dividing the three sections of the walls were two stone pillars. These had a chamfered panel.

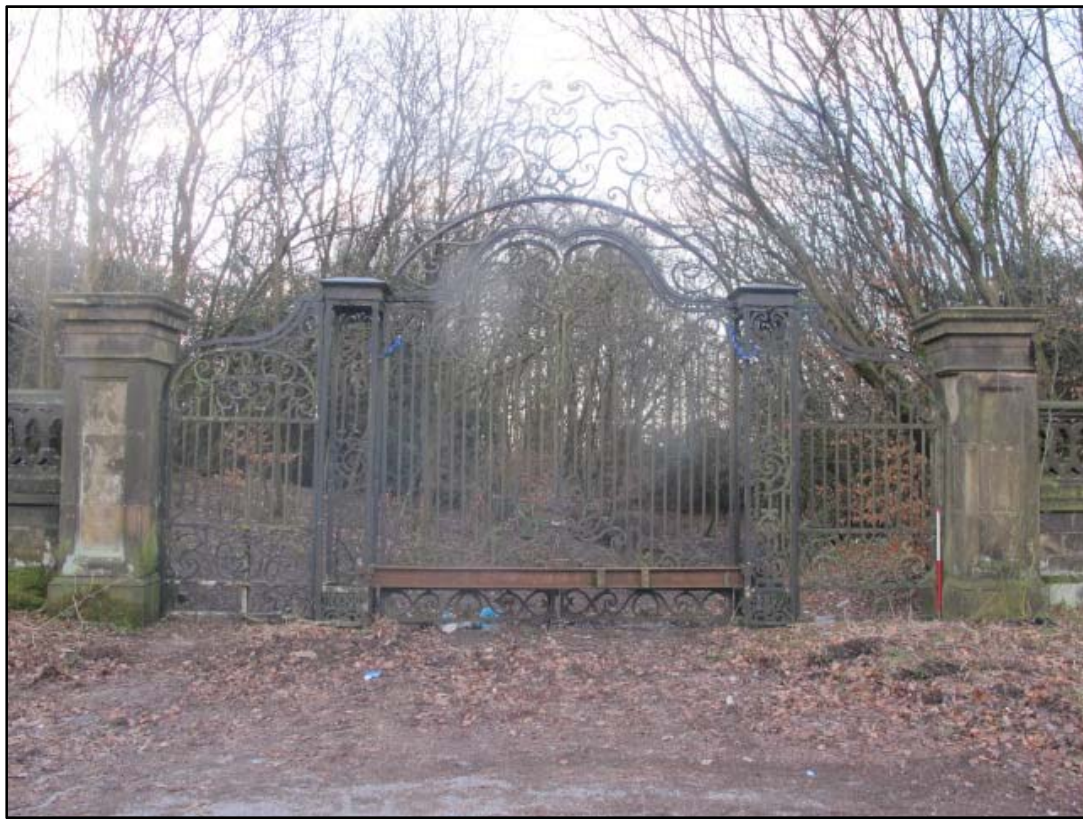
Fig. 11 – Shot of carriage and pedestrian gates. Looking south.

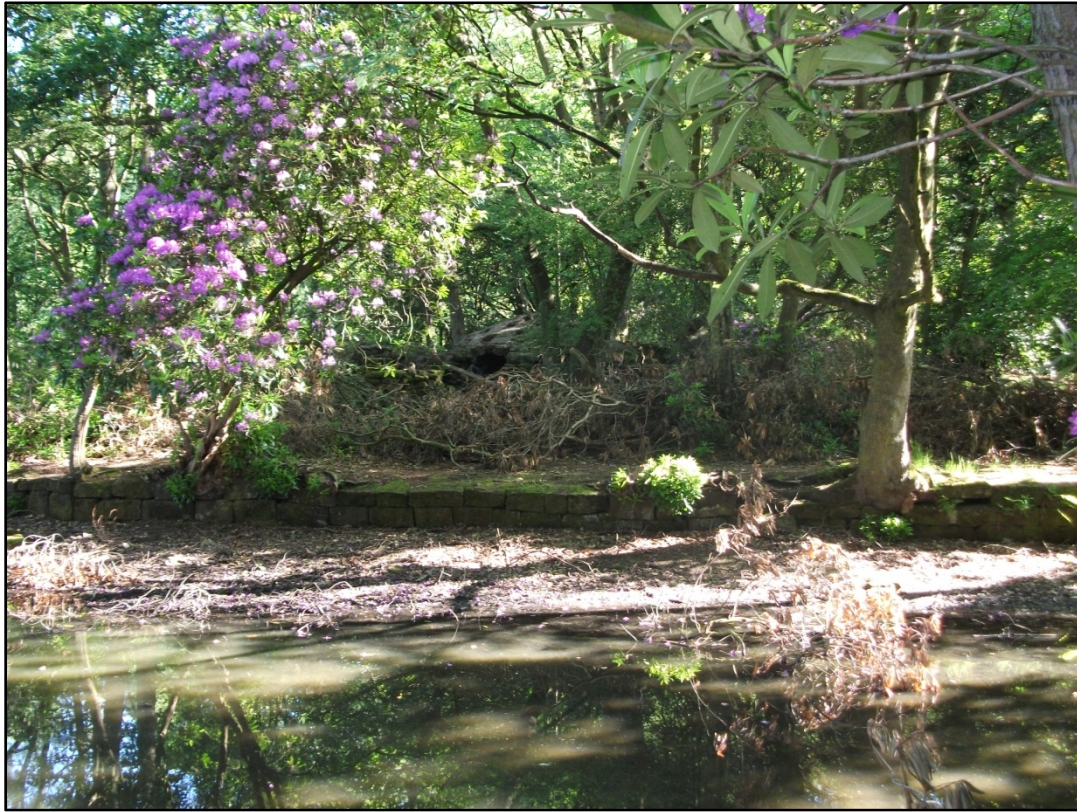
Fig. 12 - View of western half of Grotto and its location adjacent to lake. Looking east.

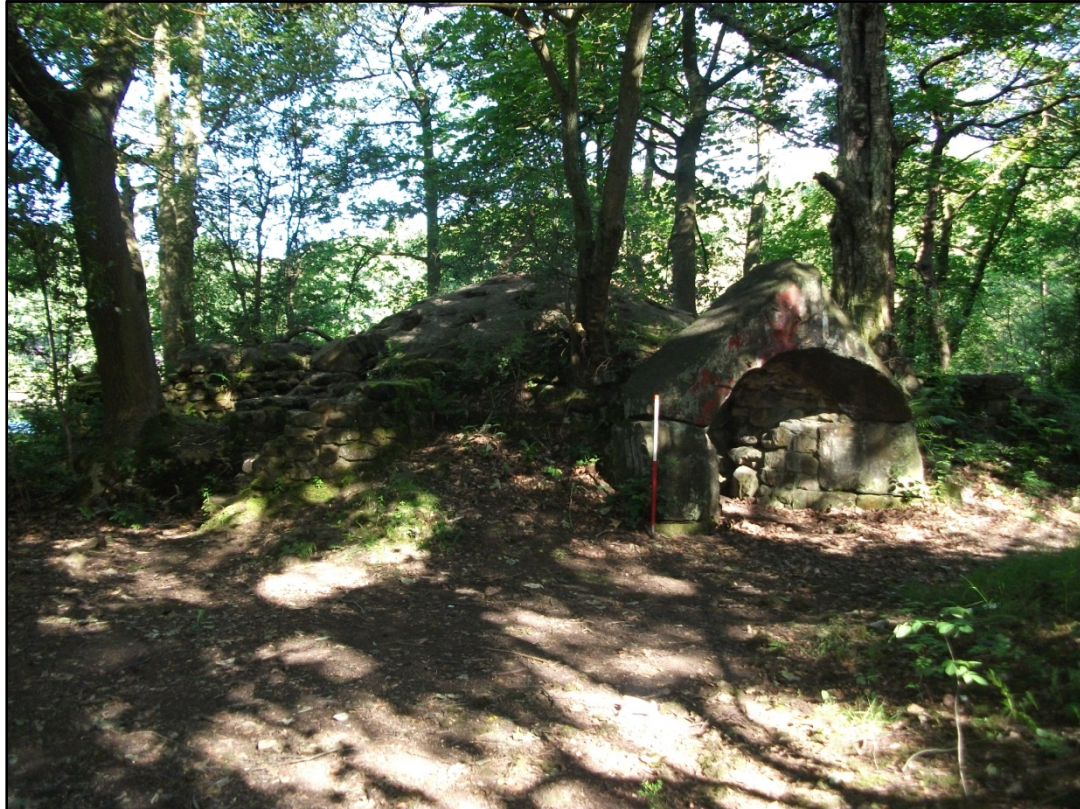
Fig. 13 - General view of the Grotto's south-east elevation. Looking north-west.

The Grotto was built in an irregular style. Different materials, bonds and styles were used. The majority of the construction was stonework. The walls of the three chambers and walls and roofs of the covered walkways were all rough stonework. These features were a random rubble construction and the stones were an irregular shape and size. The courses of all walls were laid to no pattern. The entrances and doorways had larger and more regular stones as quoins.

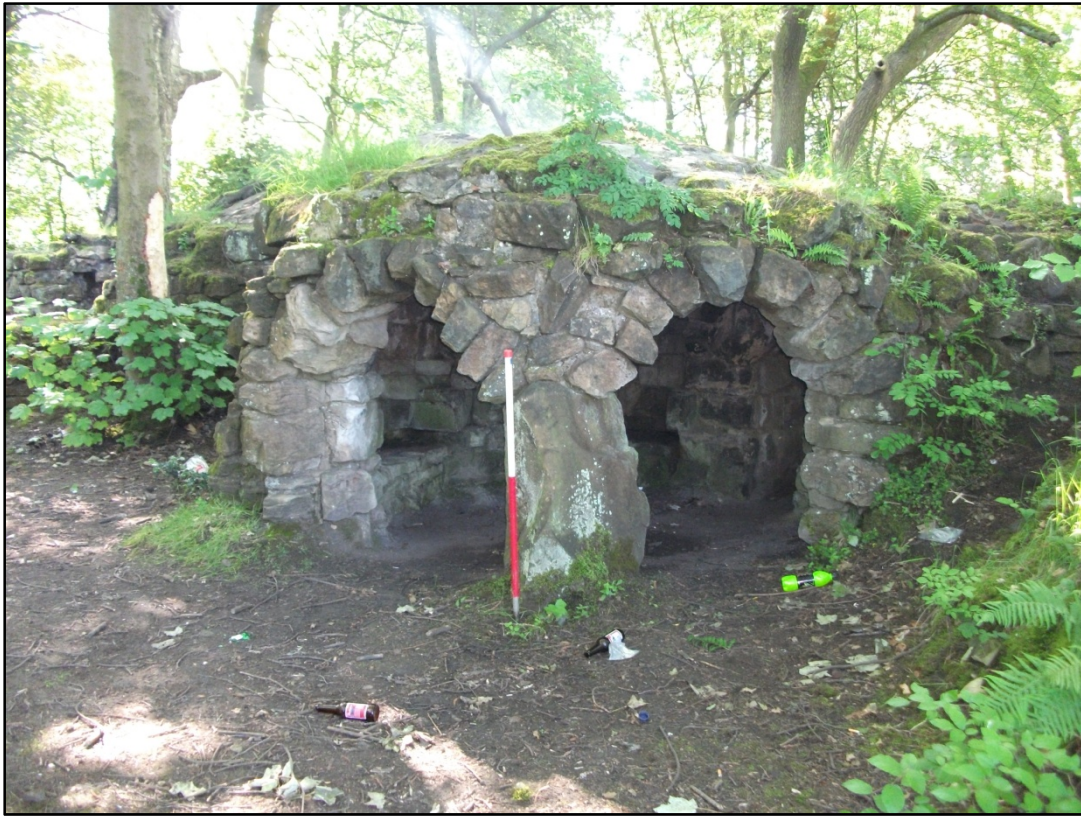
Fig. 14 – Shot of western small chamber entrance. Looking east.

The smaller western chambers were accessed by the covered walkways that protruded from the main chamber between them. They were also accessed by openings at the western part of these smaller chambers. These openings were formed by two segmented archways of stone quoins. The openings had one large stone plinth in between them. This supported one side of each archway and the other sides were built up from floor level. Larger, squared stones were used for the arches. Both had a larger chamfered keystone. The roofs on the smaller chambers were stone and barrel vaulted. Like the walls they were constructed of roughly cut stone and laid irregularly.

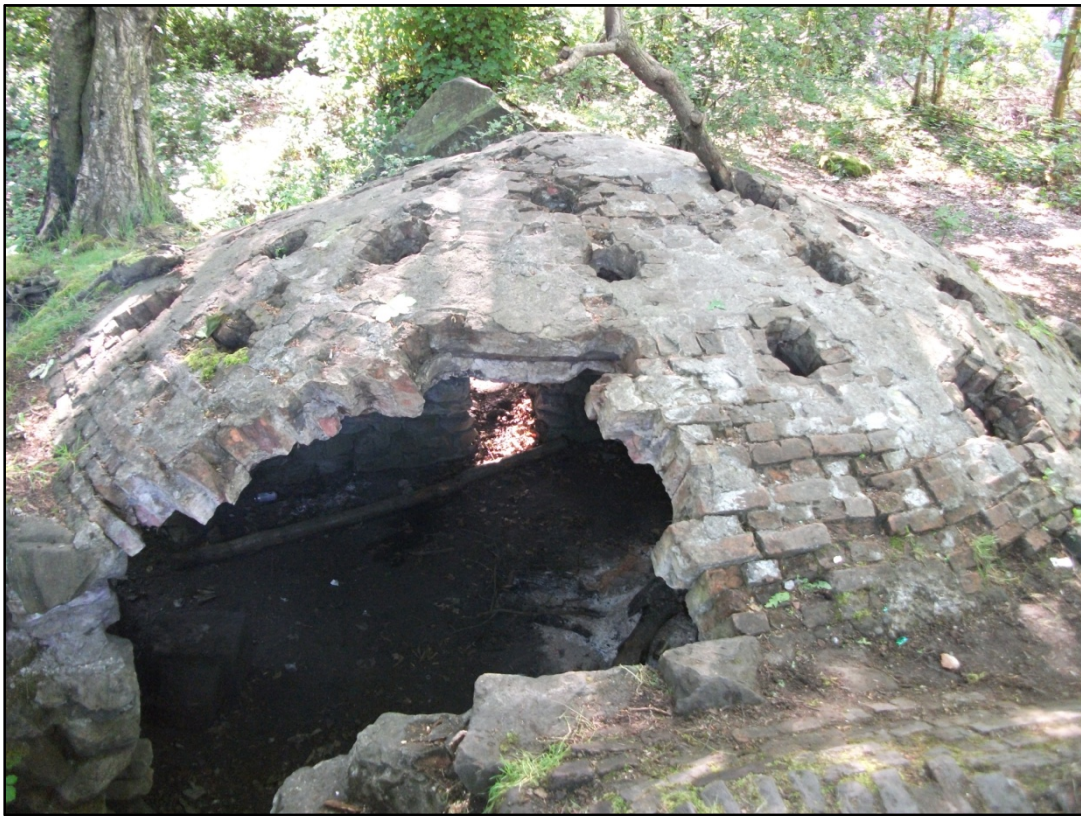
Fig. 15 – Shot of Grotto's brick roof. Looking south-east.

Access into the main chamber was an east facing arched entrance. It consisted of three stone pieces. Two stone supports were bonded to the walls of the chamber and these were surmounted by a single arched centre piece of stone spanning the entrance. The doorways into the covered walkways were formed by segmented arches of larger stone quoins bonded into the walls. Walls were brought to course to coincide with the height of quoins and openings. Four recesses were constructed into the walls internally in the main chamber. Separating each recess was a pillar of stones that served as a roof support. The recesses had stone bases that served as seats or ledges. Surmounting the stone walls of the main chamber were brick barrel vaulted roofs. The roof had small circular openings irregularly spaced. These went through the roof and were not covered.

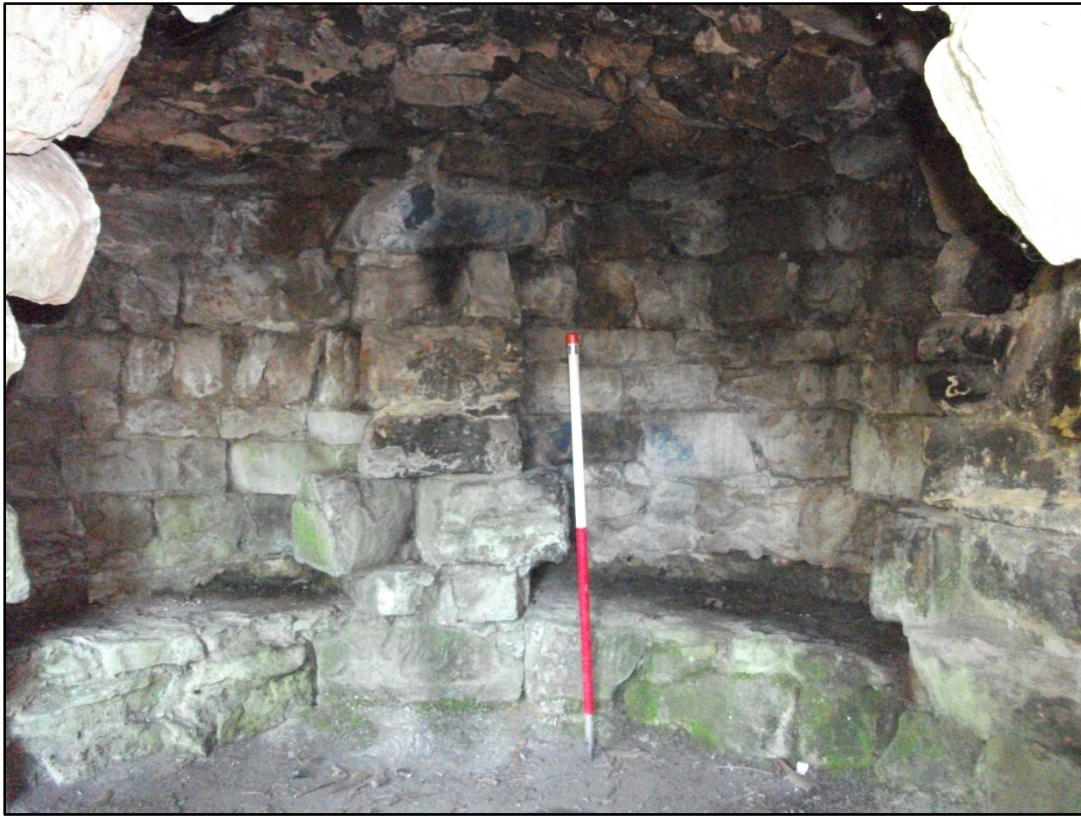
Fig. 16 – Shot of recesses and stone support inside Grotto. Looking east.

The Greater Manchester Historic Environment Record describes this structure as a Victorian Folly or Grotto. However, the current survey has not located any contemporary documentary evidence relating to the Grotto. There is, however, a photograph from the magazine *Country Life* which shows the stone walls of the Grotto on the island in 1901 (*Country Life* 20 July 1901; **Fig 23**). Site visits have confirmed that the structure consisted of three stone-built circular chambers, which were connected by several internal and external passageways. The larger central chamber had a brick vaulted roof and stone entrance way on its eastern side. The two smaller chambers contained double-arched entrance ways on their western sides which had a central stone support.

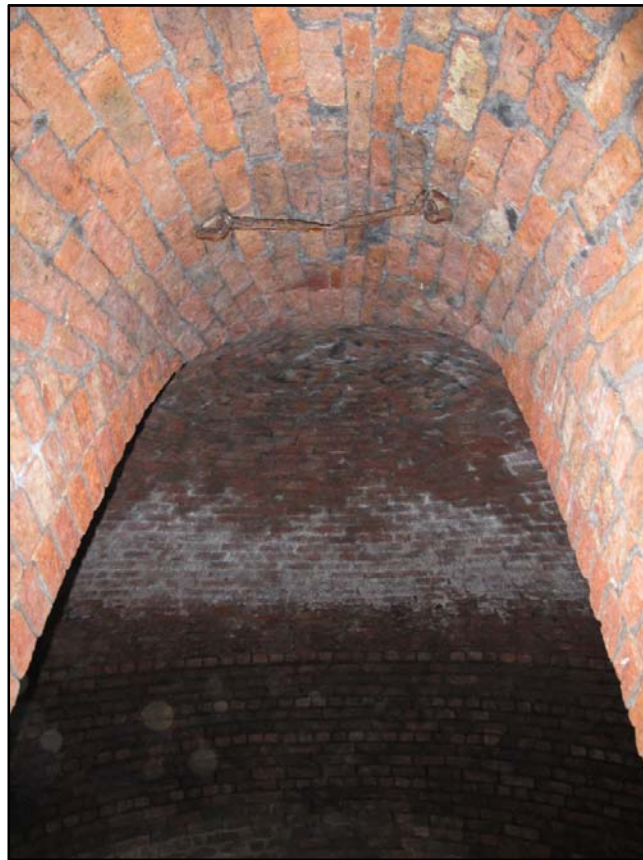
Fig. 17 – Shot of approach chamber barrel vaulted roof and iron bar fixture. Looking south.

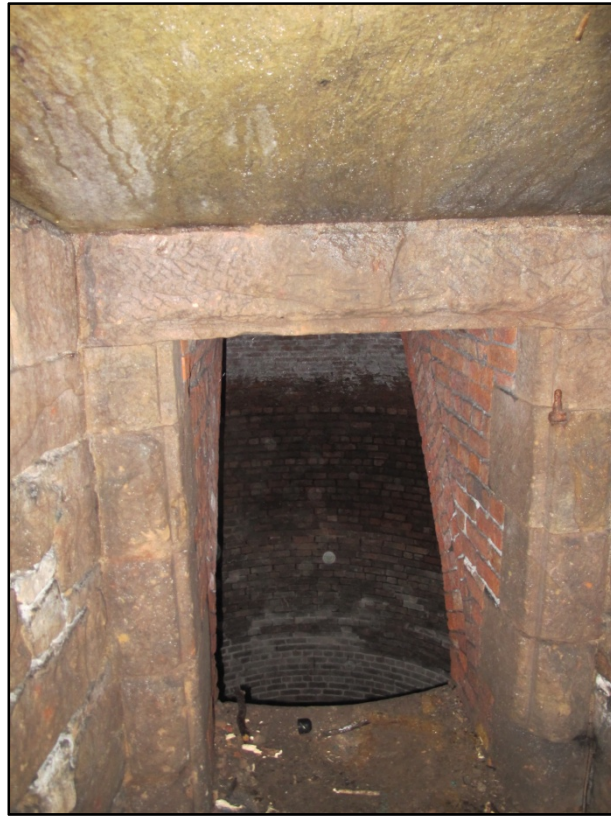
Fig. 18 – Shot of doorway into ice chamber. Looking south.

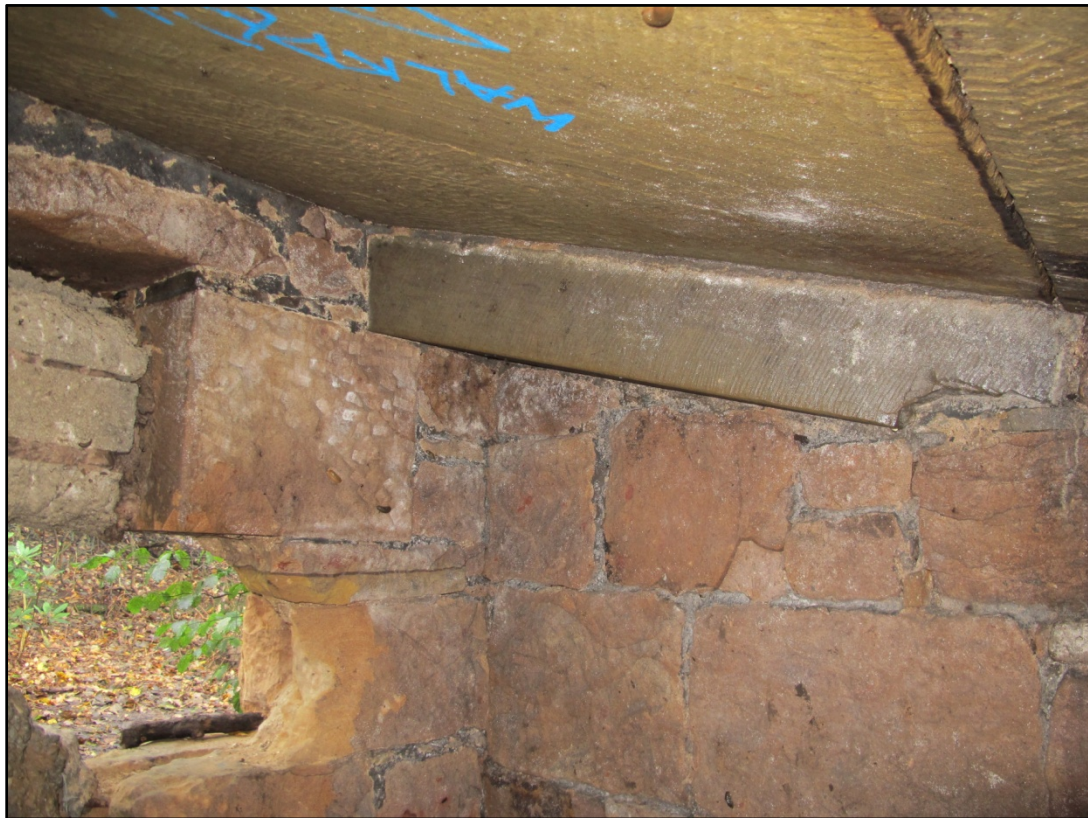
Fig. 19 – Shot of stone lined approach chamber and partially blocked entrance. Looking North-east.

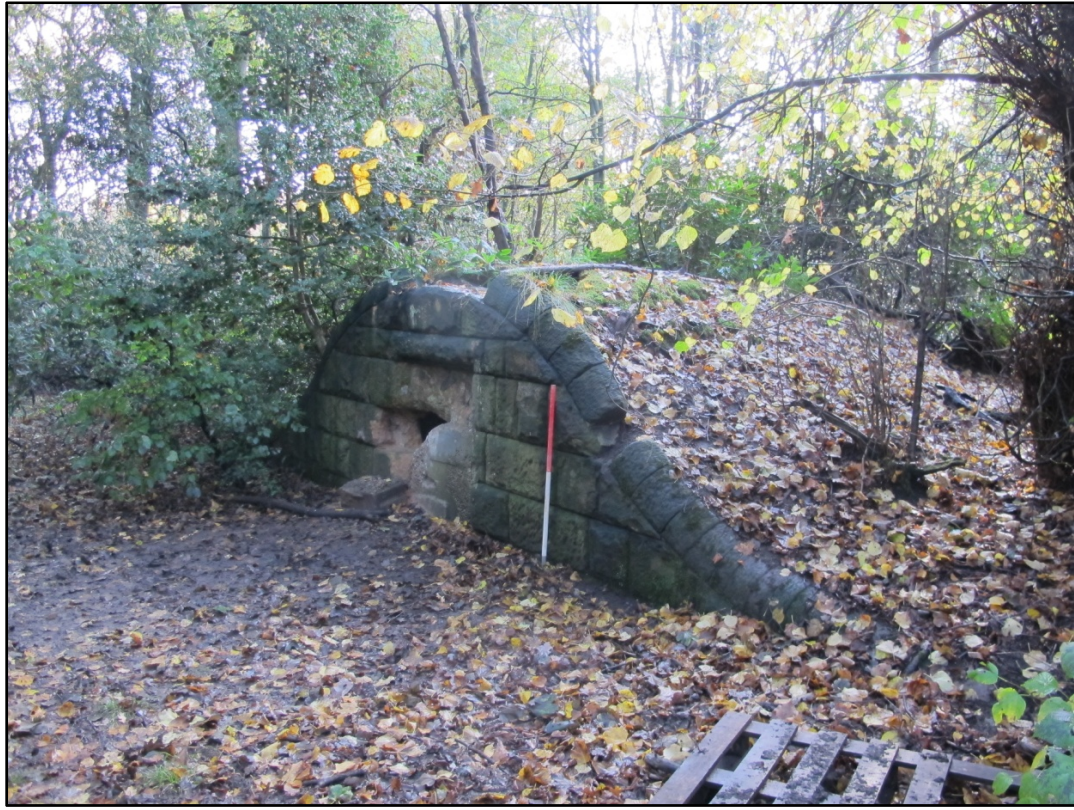
Fig. 20 – Shot of northern elevation of ice house. Looking south-east.

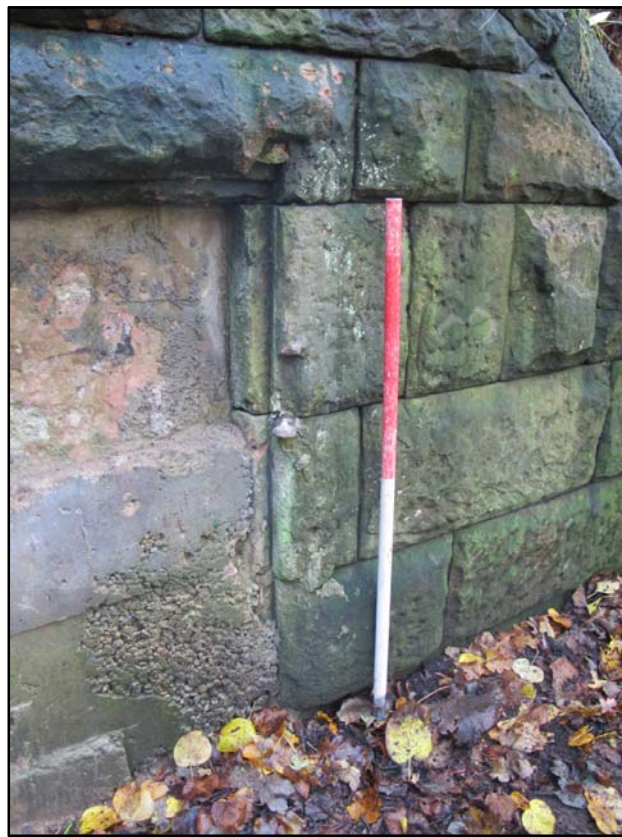
Fig. 21 – Detail of blocked doorway in northern elevation of ice house. Looking south.

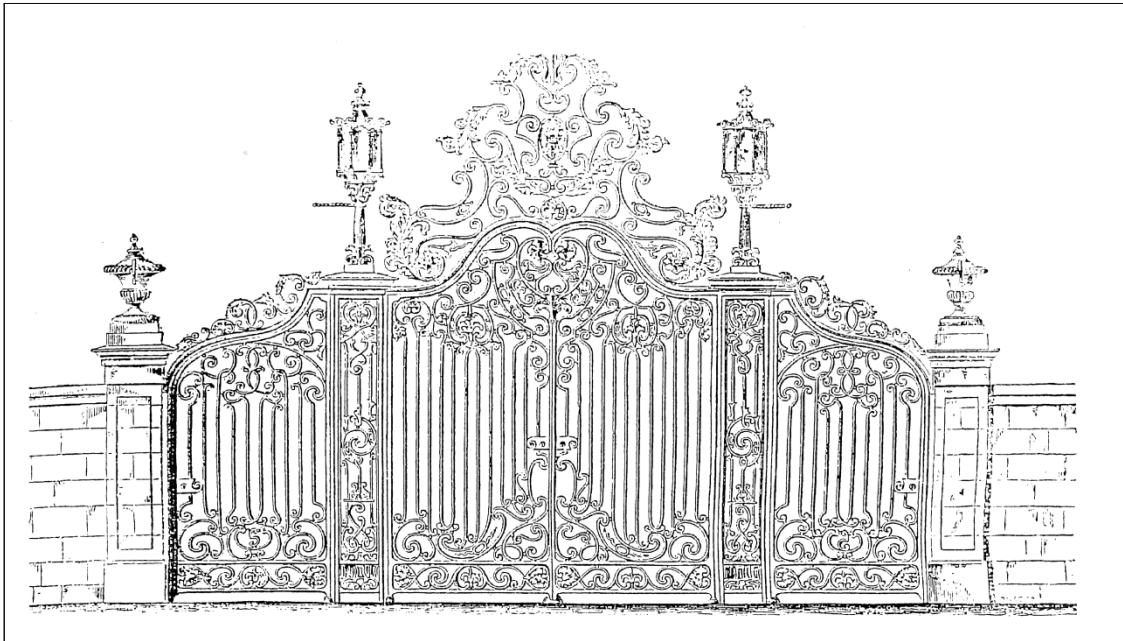
Fig 22: A copy of the illustration of the Worsley New Hall gates published in 'The Builder' 10 December 1853.

Heritage, 1987: EHB211996). The gates were constructed in wrought iron, with decorative cast-iron Baroque-style scroll work above the carriage gates. At either side of the gates were two ashlar piers with recessed panels and moulded caps, which were flanked by pierced quadrant walls (English Heritage, 1987: EHB211996). Documents held within the Bridgewater Estate Archive confirm that in the summer of 1940 a Manchester Corporation bus crashed into the gates, which caused substantial damage resulting in the rebuilding of one of the ashlar piers, repair of the carriageway gates' fitting and the rewiring of the lamps which sat on top of the piers (BEA/IV.C20/Vol: 837).

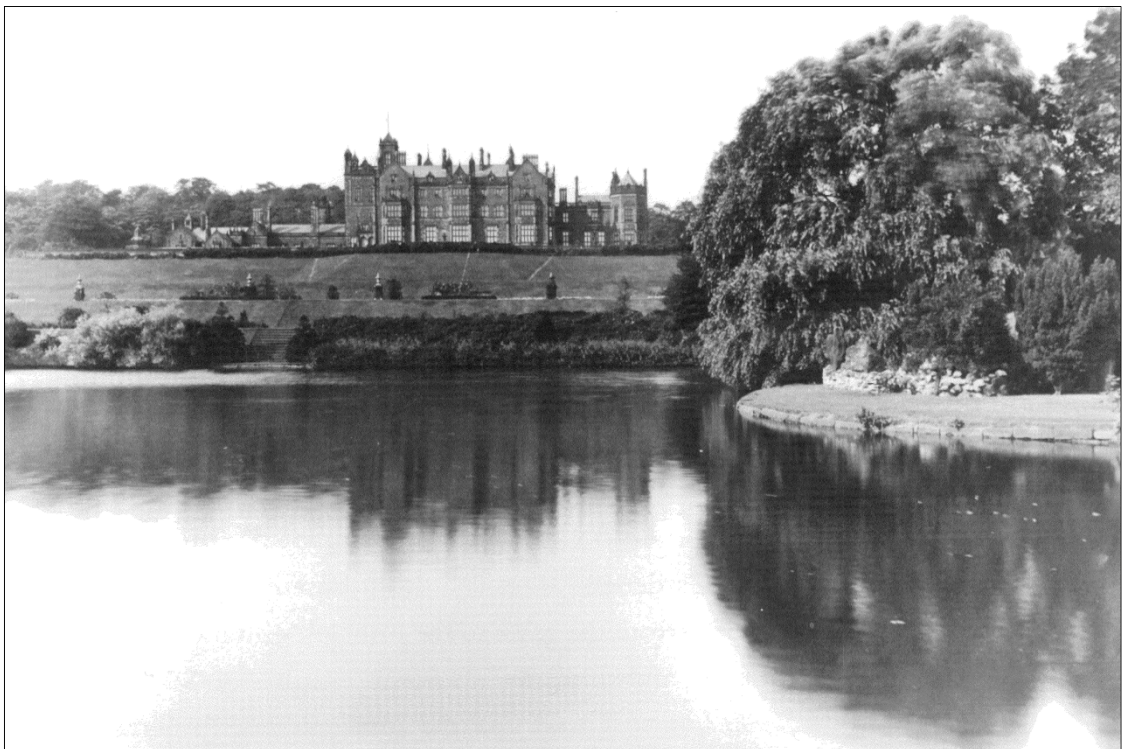
Fig 23: A view looking north across the boating lake towards Worsley New Hall. The Grotto can be seen on the island to the right. Country Life 20 July 1901.

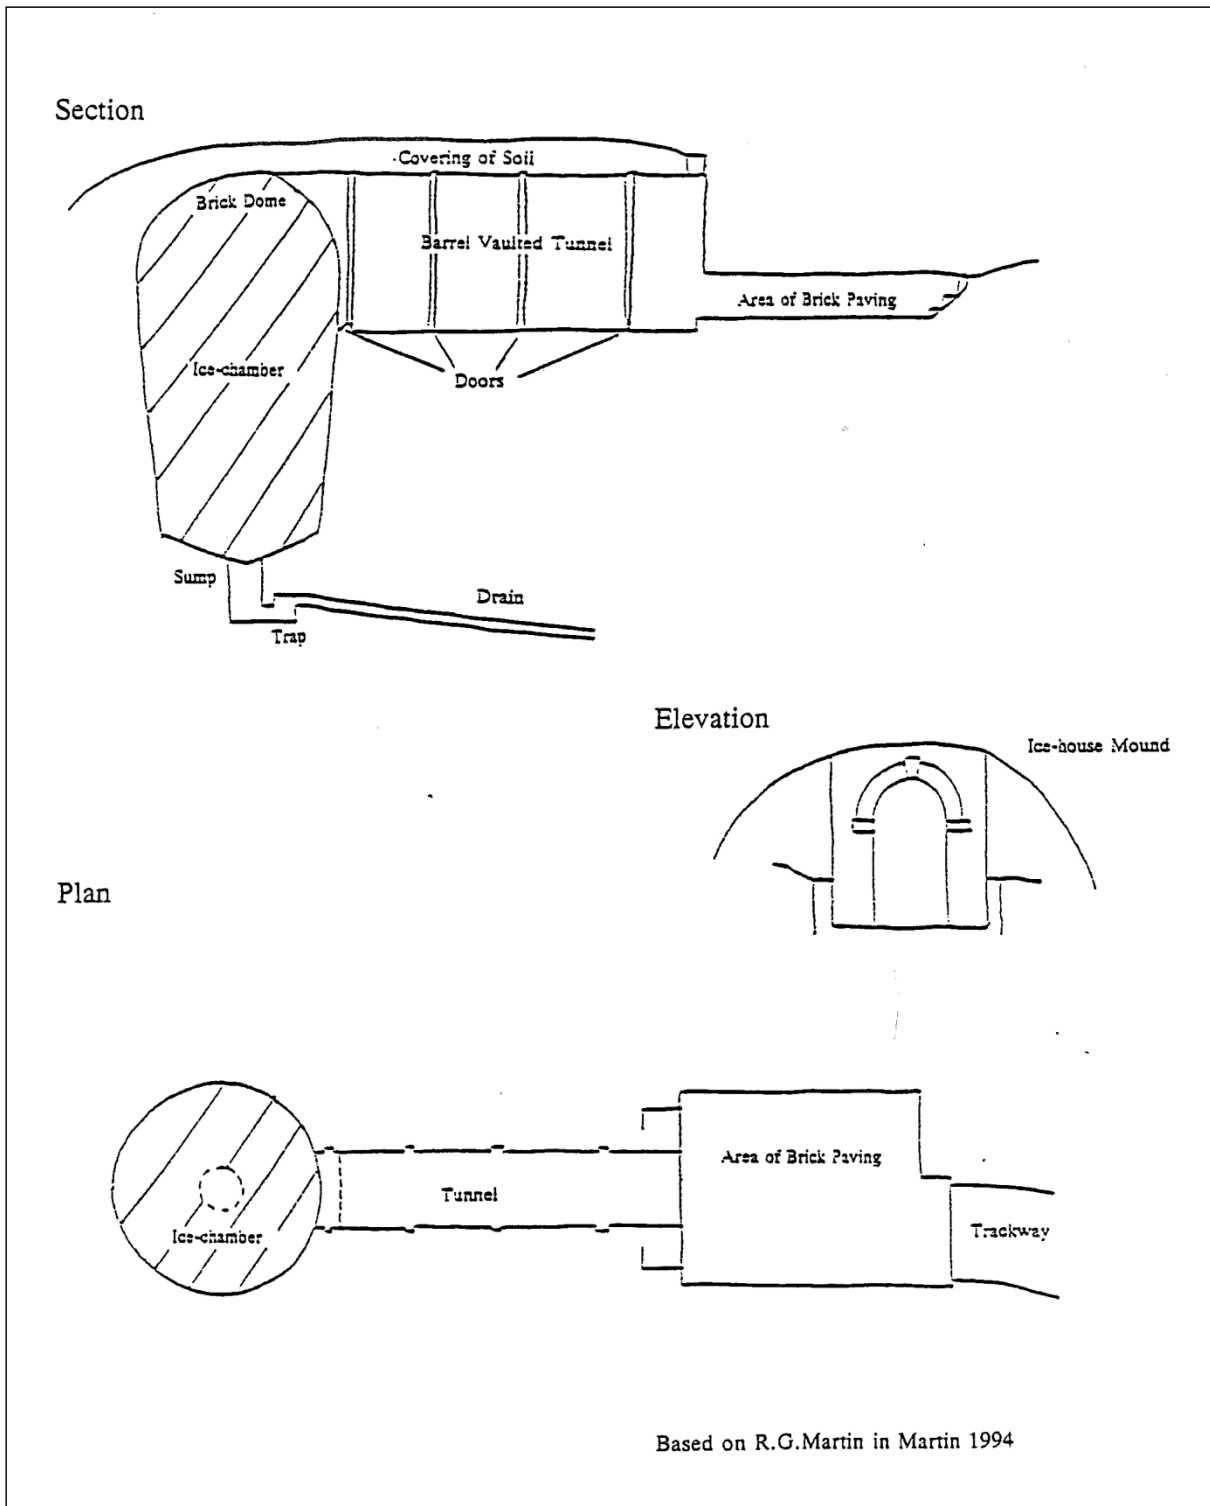
Fig 24: A sketch diagram of the main features associated with a 'cup and dome' ice house. OAU 1995, 40.
